MONUMENT RECORD

Q-13

STATE OF INDIANA - COUNTY OF MONROE

Section Fourteen (14), Township 10 North, Range 1 West

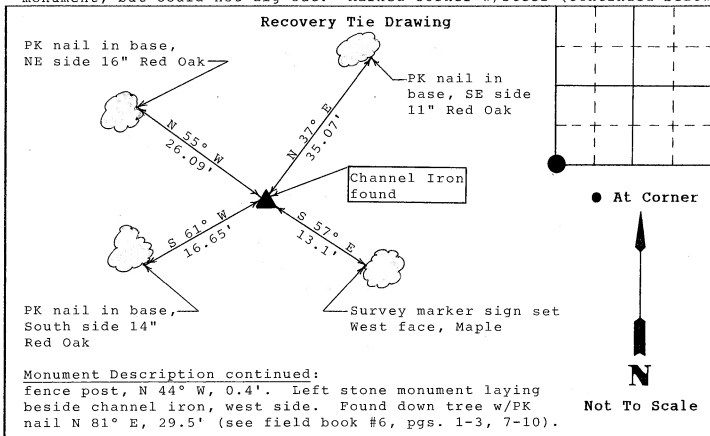
Monument Description & Remarks: Found Channel Iron at SW corner of section,
0.14' x 0.12' x 1.0' out of ground. Attempted to replace iron w/stone
monument, but could not dig out. Marked corner w/steel (continued below)

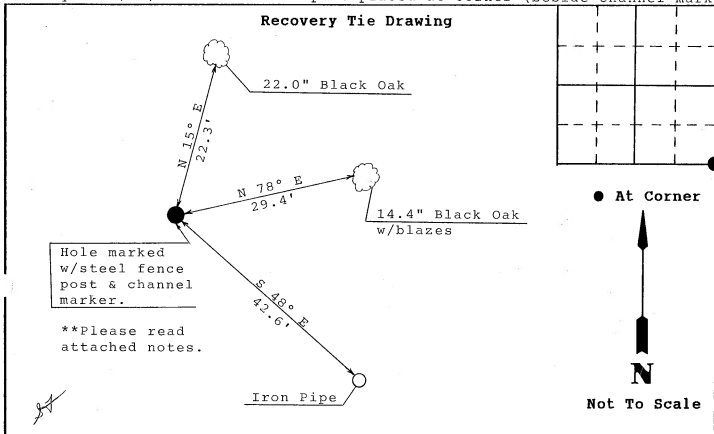
Monument Description & Remarks: Based on evidence, hole at SE Corner accepted as section corner 10/18/85. Location of corner substantiated by County Surveyor? 7/29/88--Steel fence post placed at corner (beside channel marker)
